INDEPENDENT ORBITER ASSESSMENT

ANALYSIS OF THE ORBITAL MANEUVERING SYSTEM

12 JANUARY 1987

WORKING PAPER NO. 1.0-WP-VA86001-21

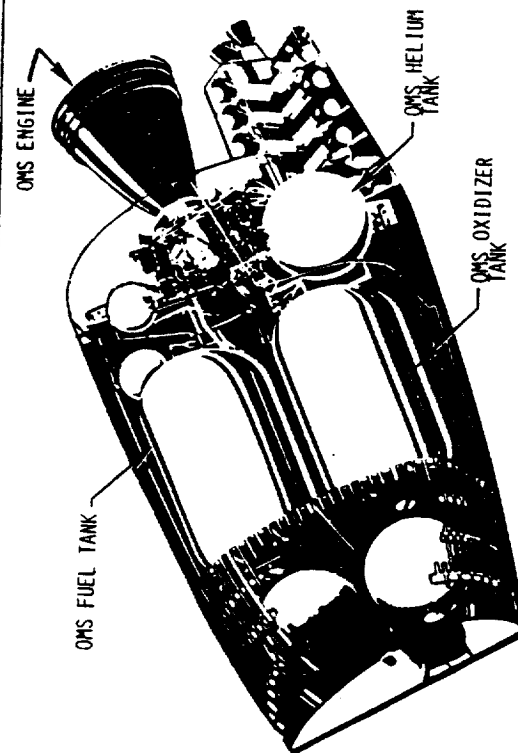
Figure 1 - OMS OVERVIEW ANALYSIS SUMMARY

Figure 1 presents a summary of the failure criticalities for each of the four subsystems of the OMS. A summary of the number of failure modes, by criticality, is also presented below with Hardware (HW) criticality first and Functional (F) criticality second.

Summary of IOA Failure Modes By Criticality (HW/F)							
Criticality:	1/1	2/1R	2/2	3/1R	3/2R	3/3	TOTAL
Number :	54	150	9	139	325	274	951

Of the 951 failure modes analyzed, 376 were determined to be PCIs.
